Confidential Home Inspection Report

**123 WeMAR Street
Phoenix AZ 85301**

Date: 7/31/2011	Time: 08:30 AM	Inspection ID: Sample-07JL
Property Address: 123 WeMAR Street Phoenix AZ 85301	Customer: Another Great Client	Real Estate Professional: Another Amazing Realtor

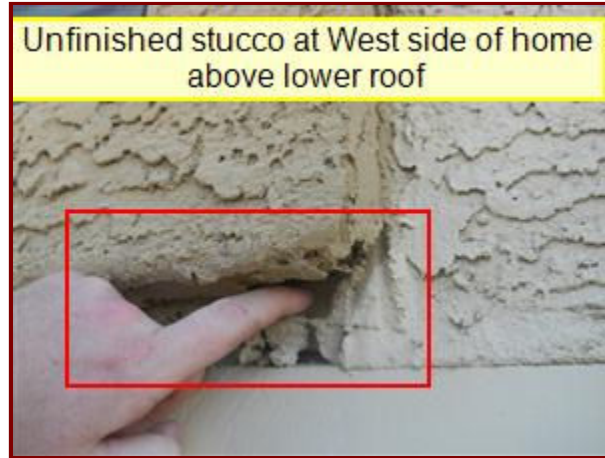
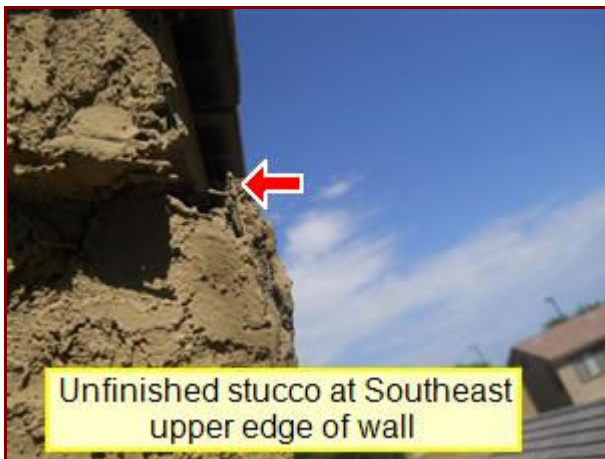
2.0 Picture 1

(1) At the West side of the home directly above the lower roof flashing there is unfinished stucco with exposed foam and metal lath below the window. The joint between the stucco and metal flashing also needs to be sealed. I recommend these be repaired by a qualified contractor to prevent moisture and pest infiltration that can lead to further deterioration.

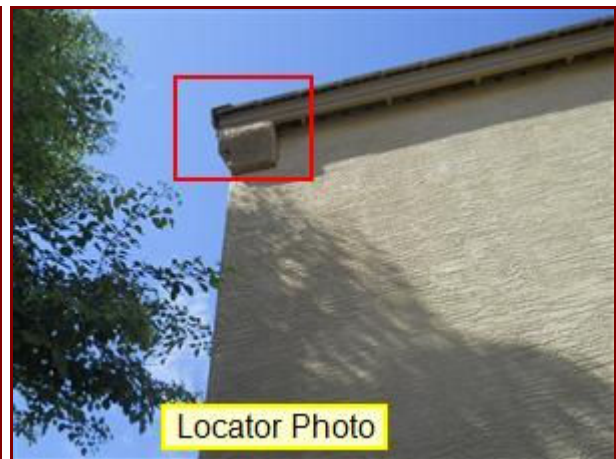
2.0 Picture 3

(2) At the Southeast exterior upper corner of the home, the stucco is not finished at the top of the decorative corner bump-out. I recommend this be repaired by a qualified contractor to prevent further deterioration due to moisture and pest infiltration.

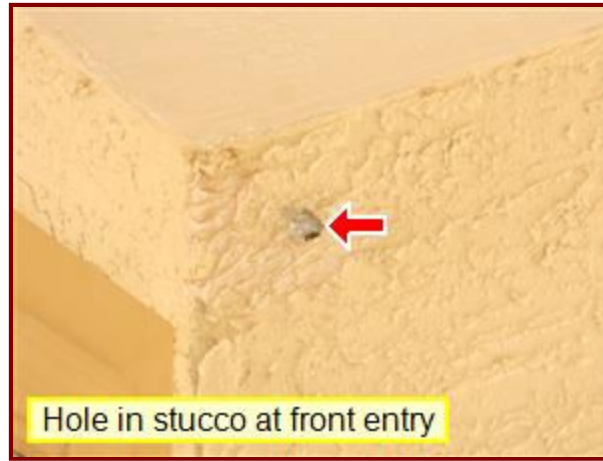
2.0 Picture 4

Hole in stucco at front entry

(3) At the stucco adjacent to the front entry door there is a hole approximately 1" in diameter that has been drilled through the wall. I recommend this be patched to prevent moisture and pest infiltration that could lead to deterioration.

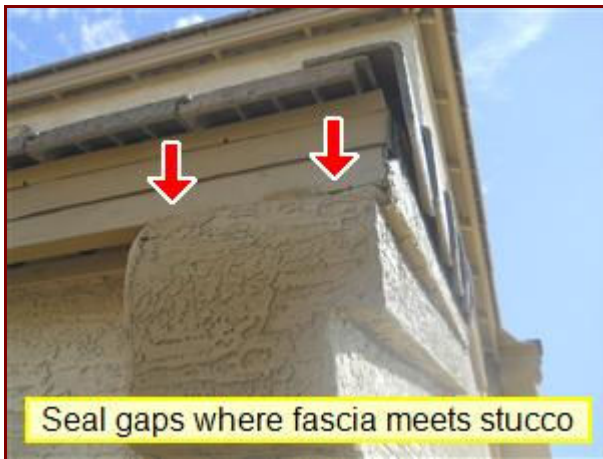
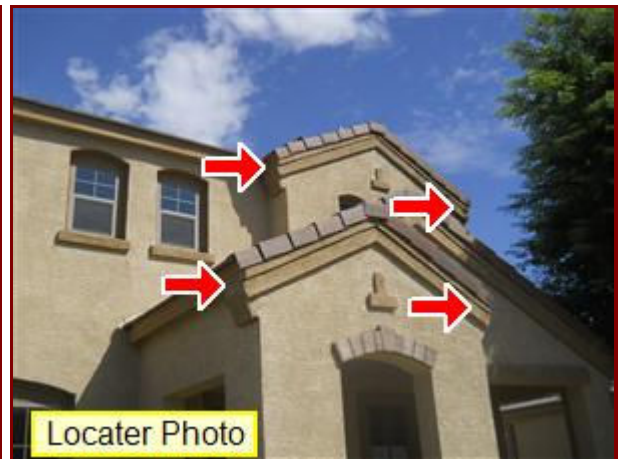
2.0 Picture 5

Seal gaps where fascia meets stucco

(4) At the South side of the home where the fascia board meets the stucco there are gaps at several areas. I recommend all areas where the fascia board meets the stucco be sealed with exterior grade sealant to prevent moisture penetration behind the stucco that could lead to future deterioration.

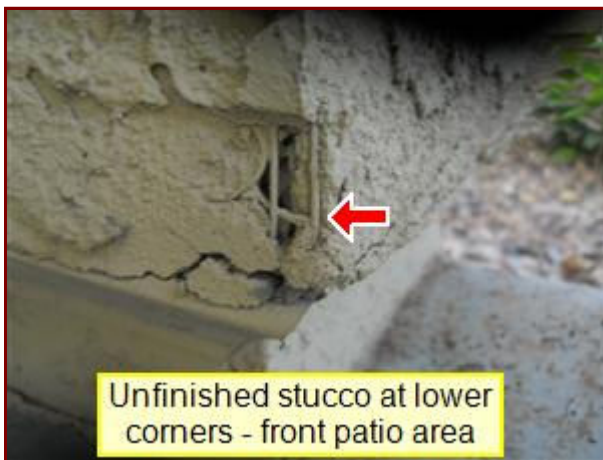
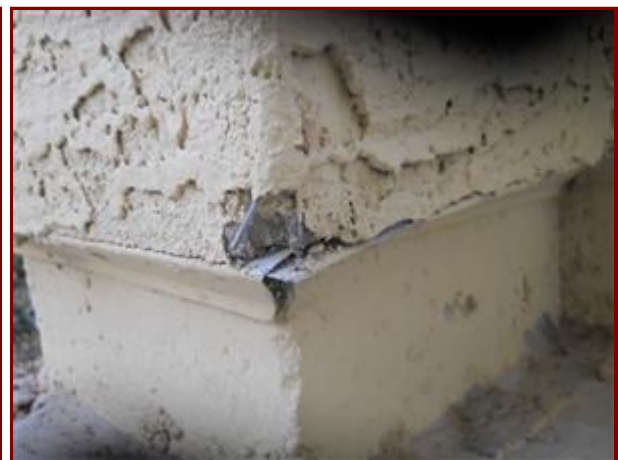
2.0 Picture 7

Unfinished stucco at lower corners - front patio area

(5) At numerous exterior corners on the lower edge of the stucco there are areas of minor deterioration or visible metal lath due to improperly finished stucco. I recommend these areas be patched to prevent moisture and pest infiltration that can lead to further deterioration.

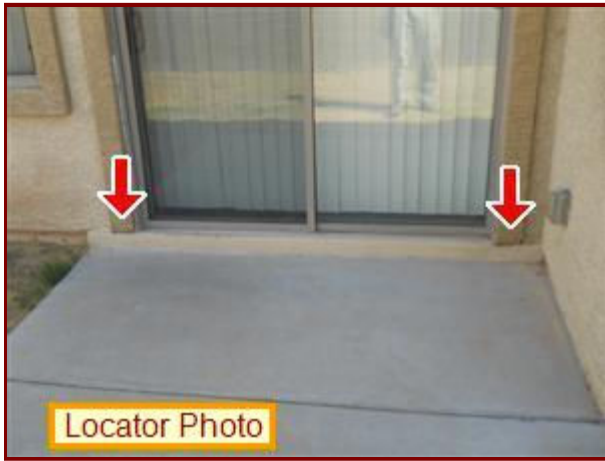
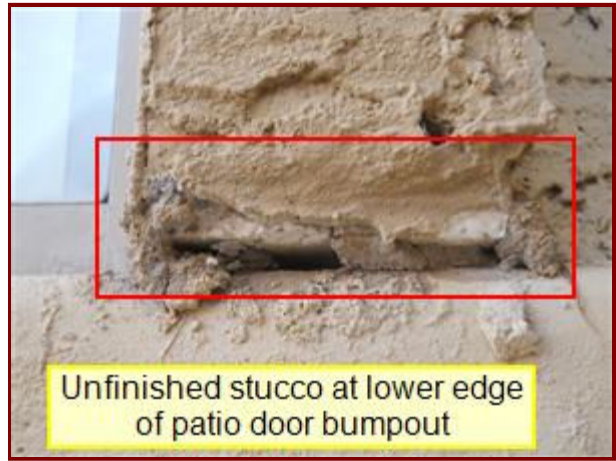
2.0 Picture 10

Unfinished stucco at lower edge of patio door bumpout

(6) At the sliding door to the rear yard, the lower edge of the stucco bump-out trim is not finished, there is exposed foam and metal lathe. I recommend this be patched to prevent moisture and pest infiltration that can lead to future deterioration.

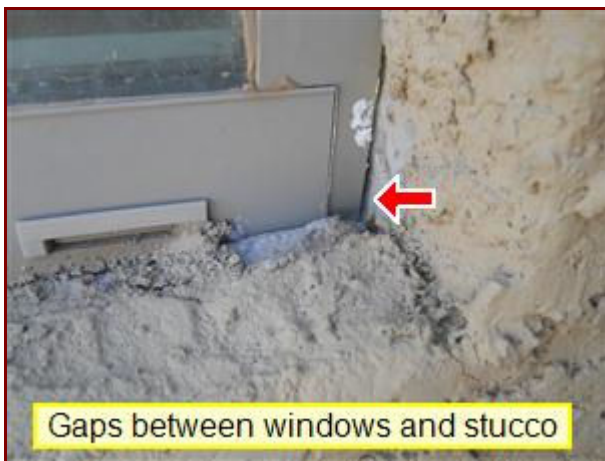
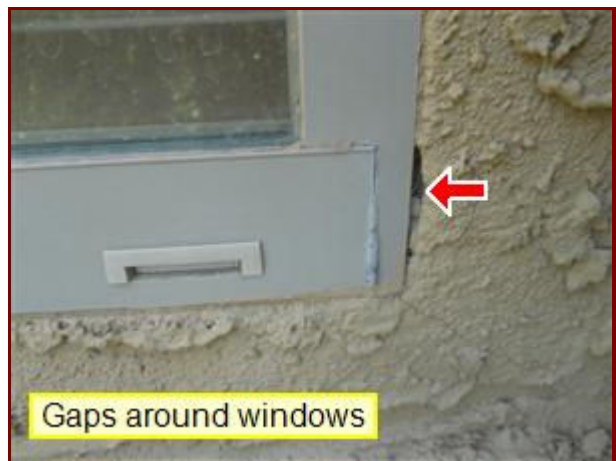
2.0 Picture 11

Gaps between windows and stucco

Gaps around windows

(7) Around the majority of the windows there are minor gaps between the window frames and the stucco. These gaps are due to differential movement between the stucco and window frames which is normal. I recommend the perimeter of all windows be sealed at the exterior with exterior grade sealant to prevent moisture penetration and future deterioration.

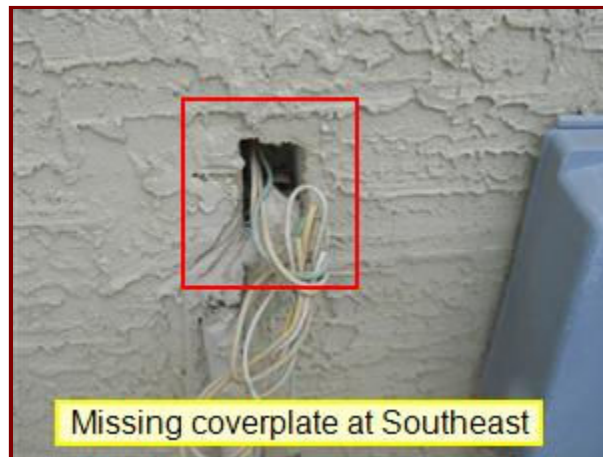
2.1 Picture 1

Missing coverplate at Southeast

(1) At the Southeast corner of the home the coverplate is missing at the phone wiring entrance. I

recommend a coverplate be installed to prevent moisture and pest infiltration.

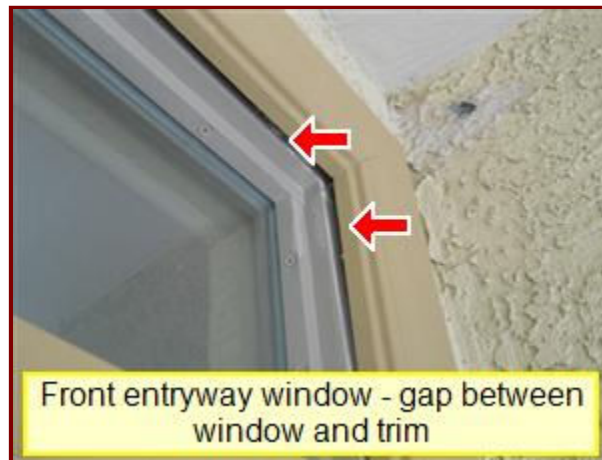
2.1 Picture 2

(2) The wooden trim around the window above the front entry door is not properly sealed. There is a gap between the window frame and the trim. I recommend this be sealed to prevent moisture penetration and deterioration.

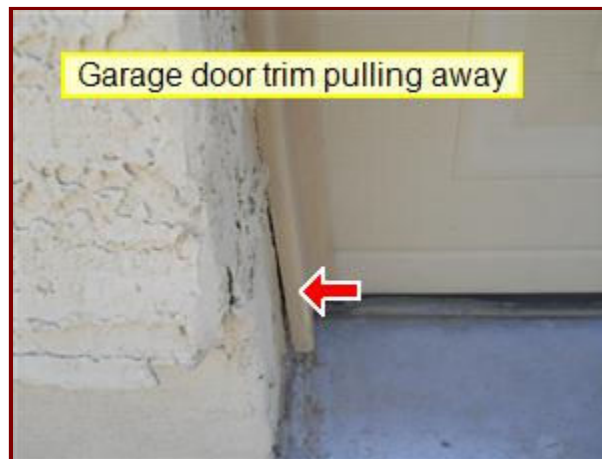
2.1 Picture 3

(3) The garage door exterior trim is pulling away from the structure in areas. I recommend a qualified person resecure this trim and seal around the perimeter of the trim with exterior latex caulk to prevent moisture and pest infiltration into the wall cladding and structure.

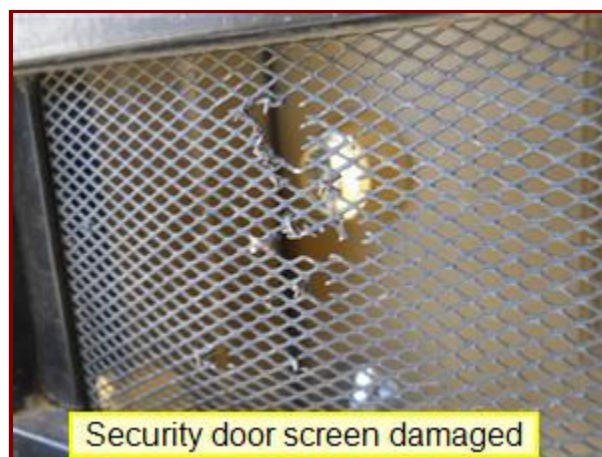
2.2 Picture 1

(1) The front entry security door screen is damaged. This damage does not affect the security, however

the damaged areas are sharp. I recommend this be repaired to prevent injury.

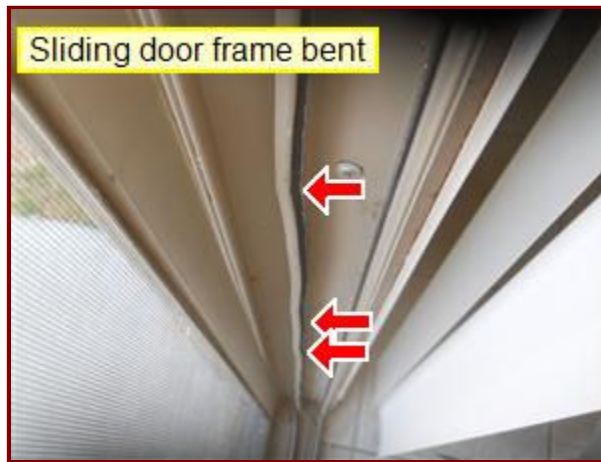
2.2 Picture 2

(2) At the sliding door to the rear yard, the door frame is bent in areas and appears to have been previously pried open. This affects the security and weatherstripping effectiveness. I recommend this be repaired by a qualified contractor.

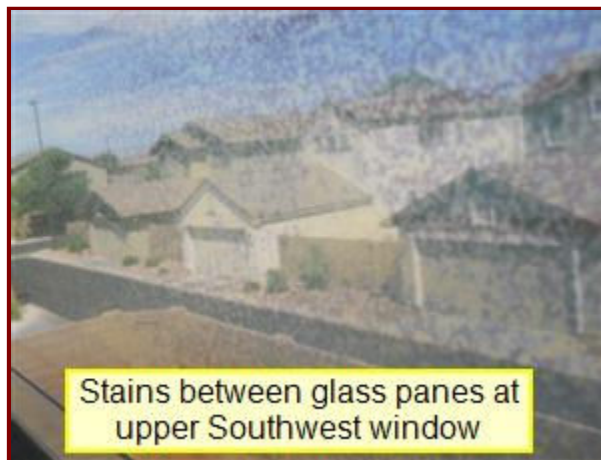
2.3 Picture 1

There is evidence of dual pane seal failure at the upstairs Southwest window. There are visible stains between the glass panes. I recommend evaluation and repair or replacement by a qualified contractor.

Failed dual pane seals can only be detected by the presence of visible moisture between the glass panes. Other windows in the home may have dual pane seal failure that is not apparent yet. The fact that there are currently failed seals means that the other windows are most likely close to the same failure.

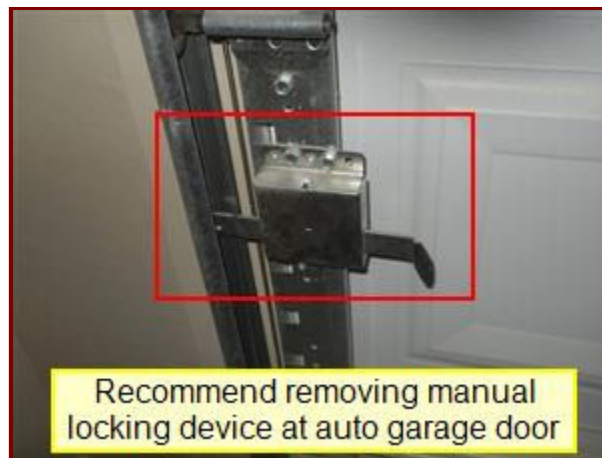
3.1 Picture 1

(2) **Recommendation:** The automatic garage door has a locking device installed, this device is designed primarily for manually operated garage doors. If this locking device is activated and the garage door is opened automatically it can cause severe damage to the garage door. I recommend this locking device be deactivated or removed to prevent accidental damage to the garage door.

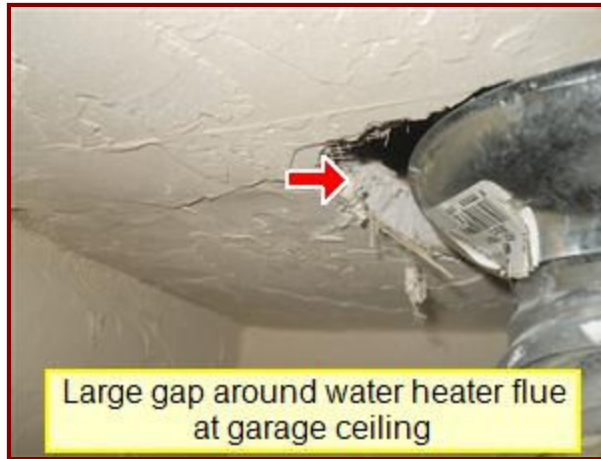
3.2 Picture 1

At the garage ceiling there is a large gap between the drywall and the water heater flue pipe that is not covered by the fire-stop flashing, this gap breaches the firewall requirement of the garage ceiling. I recommend this be repaired by a qualified contractor to maintain firewall integrity.

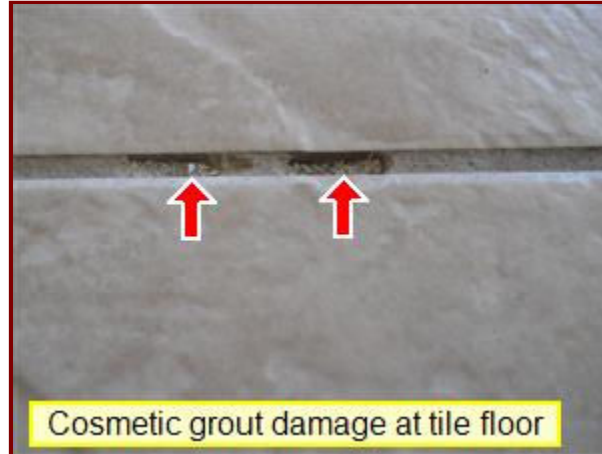
4.1 Picture 1

(1) At the tile floor there are numerous areas of damaged grout between the tiles. This appears to be due to poorly installed grout, there is no evidence of major cracking in the tile or grout. I recommend the damaged grout be cosmetically repaired.

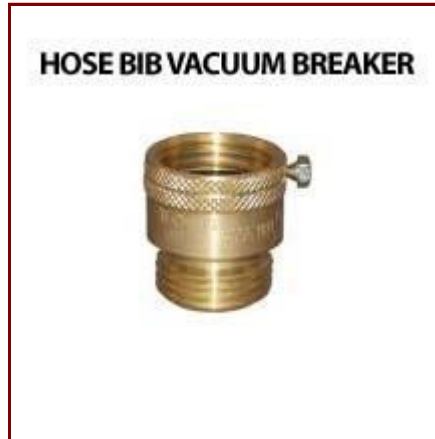
5.2 Picture 1

The front exterior hose-bib (faucet) does not have vacuum breaker fitting installed. These are required to keep non-potable water from entering the homes water supply system. These can be purchased at the local home store and easily installed by the homeowner.

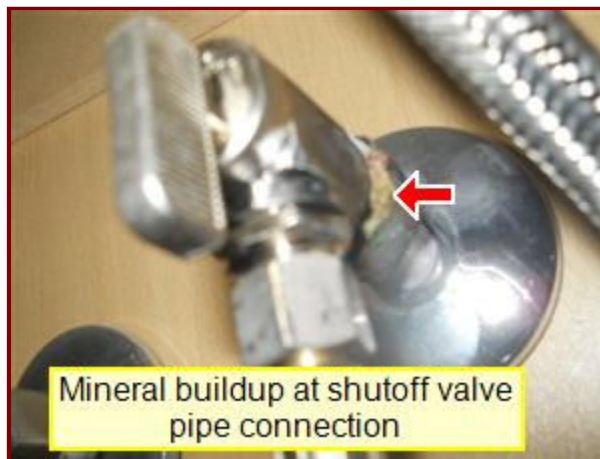
5.3 Picture 1

(1) At the master bathroom right vanity sink cold water shutoff valve (angle-stop) there is visible mineral buildup and corrosion at the pipe connection. I recommend this be replaced by a qualified plumbing contractor to prevent future leakage.

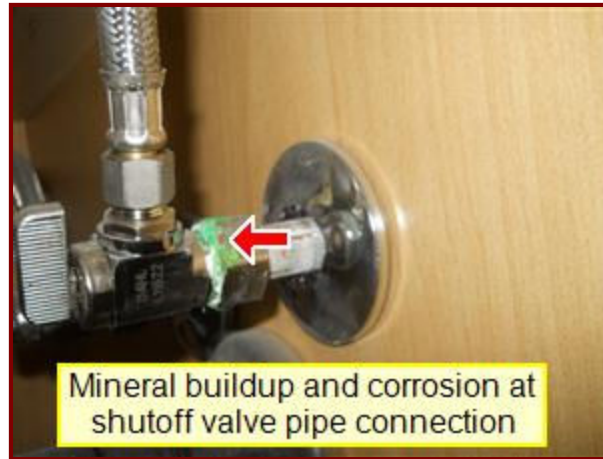
5.3 Picture 2

(2) At the downstairs hall bathroom vanity sink cold water shutoff valve (angle-stop) there is visible mineral buildup and corrosion at the pipe connection. I recommend this be replaced by a qualified plumbing contractor to prevent future leakage.

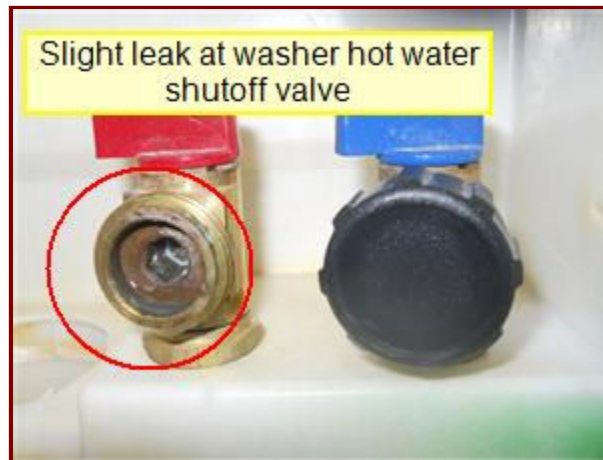
5.5 Picture 1

(1) The laundry room washing machine hot water shutoff valve has a slight water seep/leak when off. These valves are currently capped which prevents leakage onto the drywall. I recommend this valve be replaced by a qualified plumbing contractor to prevent future leakage issues.

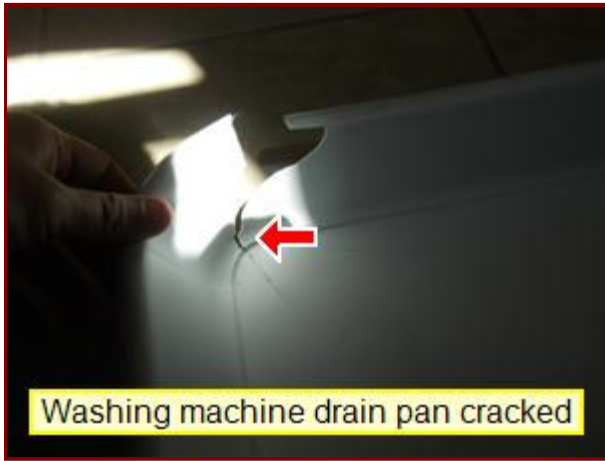
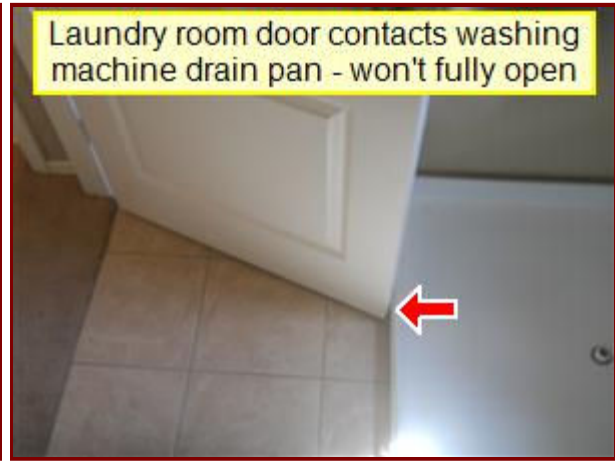
5.5 Picture 2

(2) At the upstairs laundry room, the washing machine drain pan is cracked in two places, this renders it useless. I recommend this drain pan be replaced by a qualified contractor for proper operation in the event of a washing machine leak.

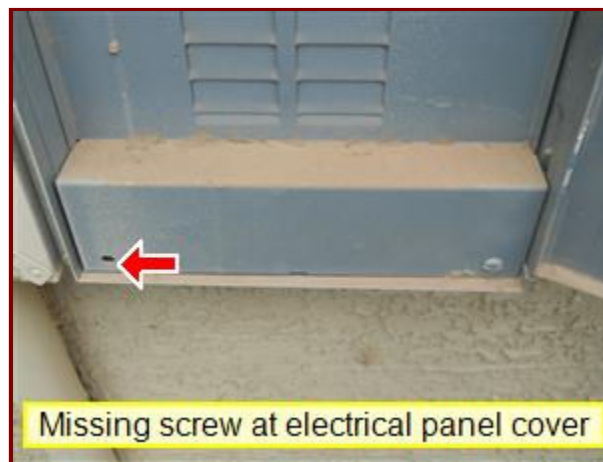
7.1 Picture 1

The main electrical panel "dead front" cover is missing one attachment screw. I recommend replacement of these screws by a qualified person with the proper type and length of screw to secure this cover in place. A loose cover can come into contact with live electrical wires.

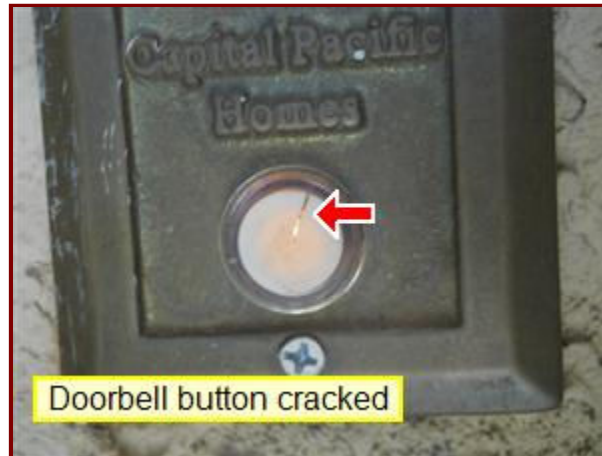
7.8 Picture 1

The doorbell button is cracked, the doorbell is operational. I recommend repair or replacement by a qualified person.

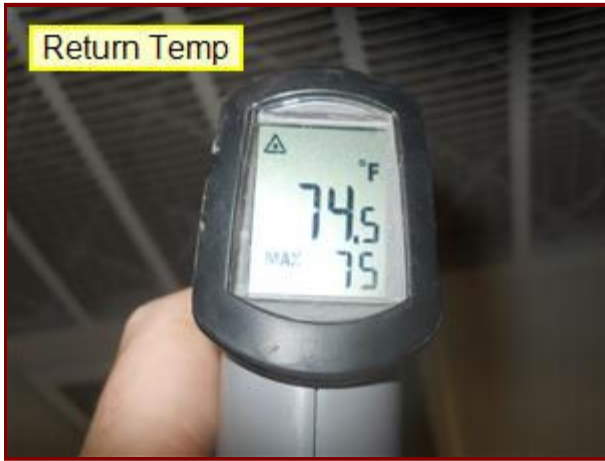
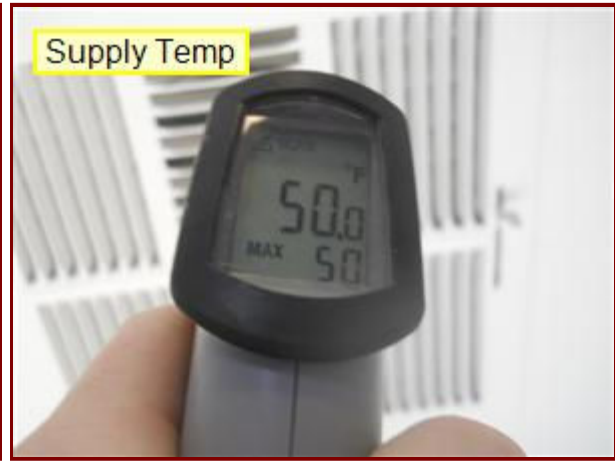
9.2 Picture 1

(1) The cooling system is tested for operation by determining the temperature split. This is the temperature differential between the air entering the return air vent and the air exiting the supply vents. A temperature split between 14 and 22 degrees F is considered normal as the industry standard.
